# **Warm Springs Run Stream Corridor Assessment**

**Kieran O'Malley**

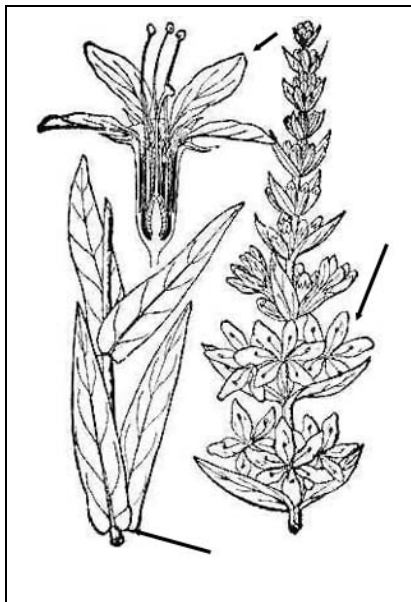
Figure 1. Purple loosestrife (*Lysimachia salicaria*) is being held in check in Morgan County by the efforts of the Purple Loosestrife Task Force. The volunteer groups' mission is to protect Harperella, an endangered plant found in the county.

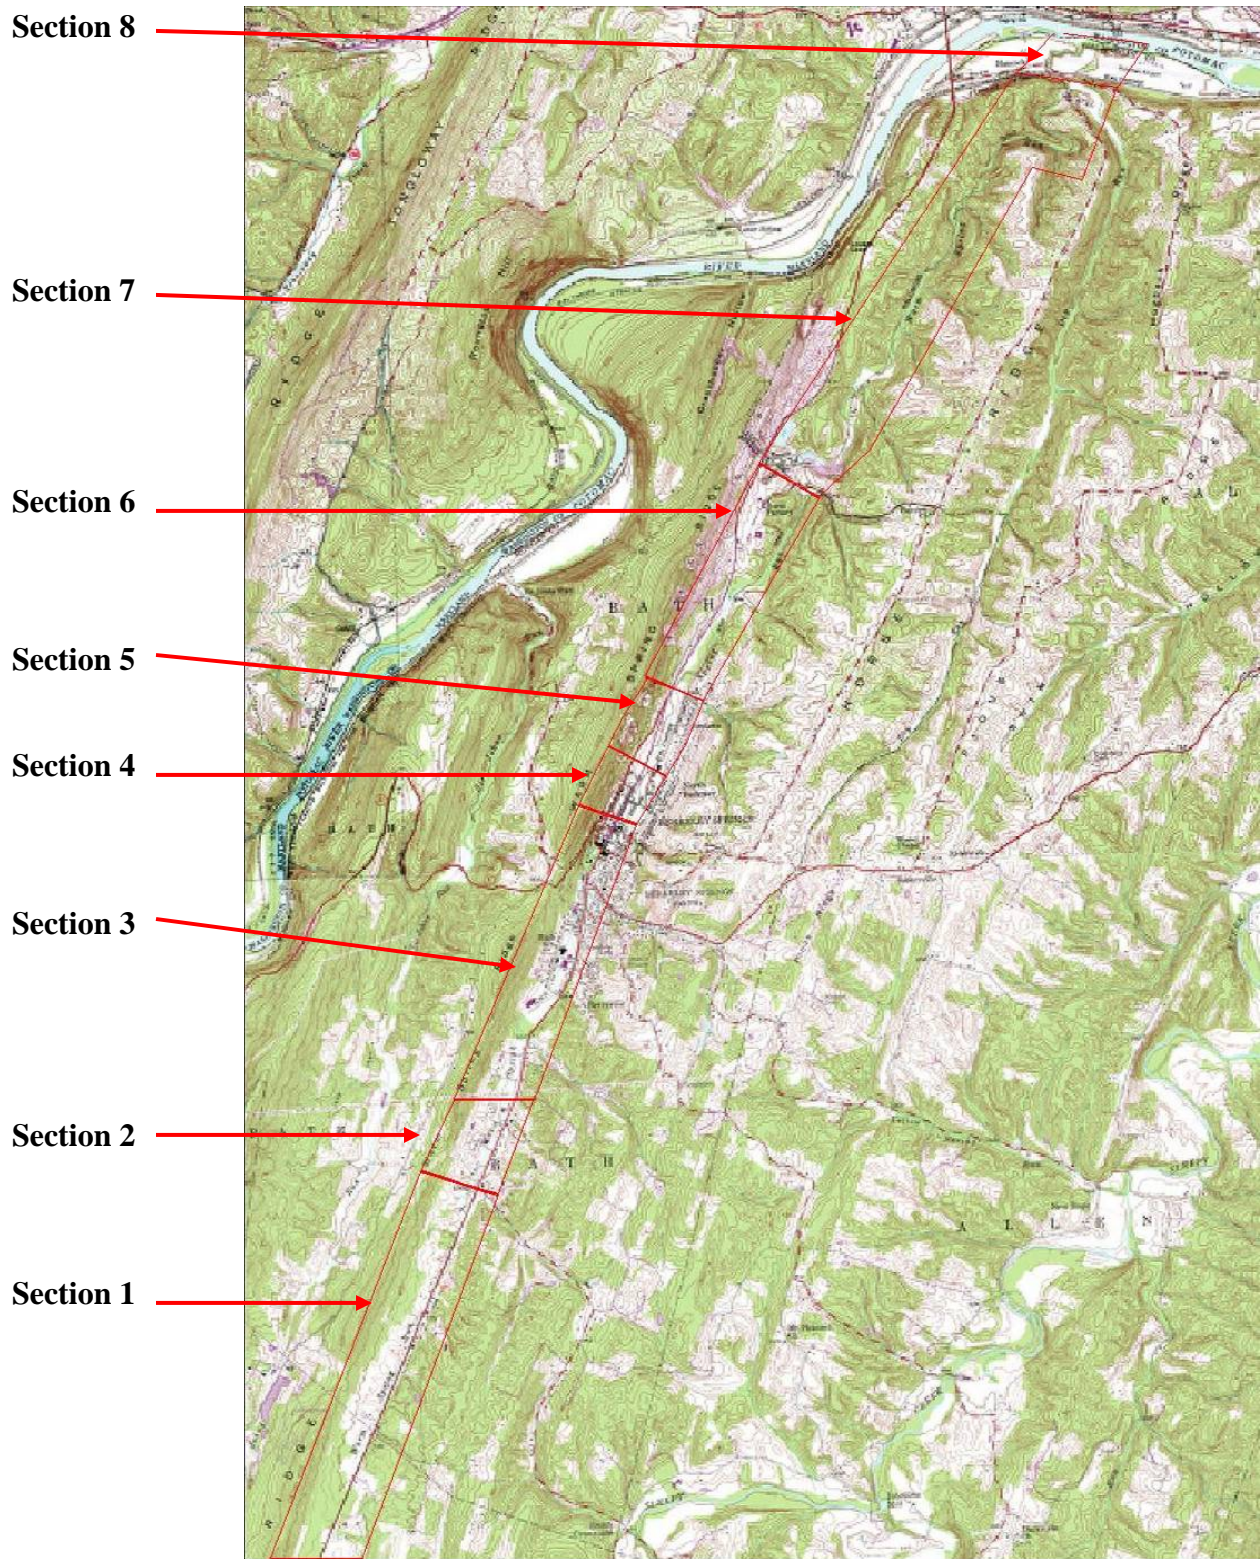
**Figure 2. Map of the Warm Springs Run Stream with Sections 1 through 8 shown.**

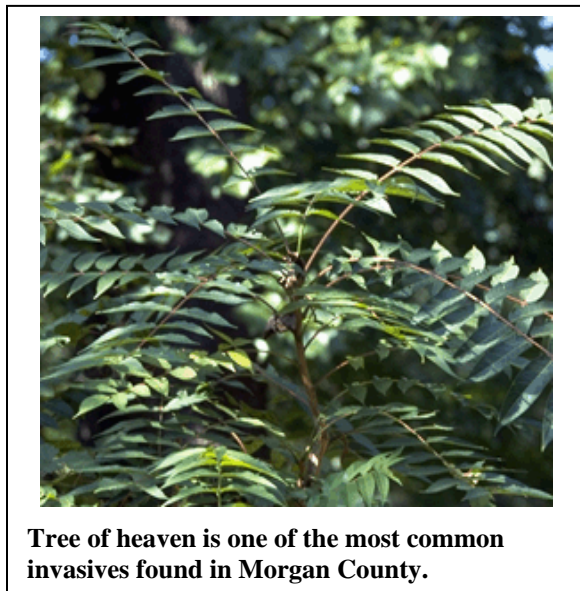
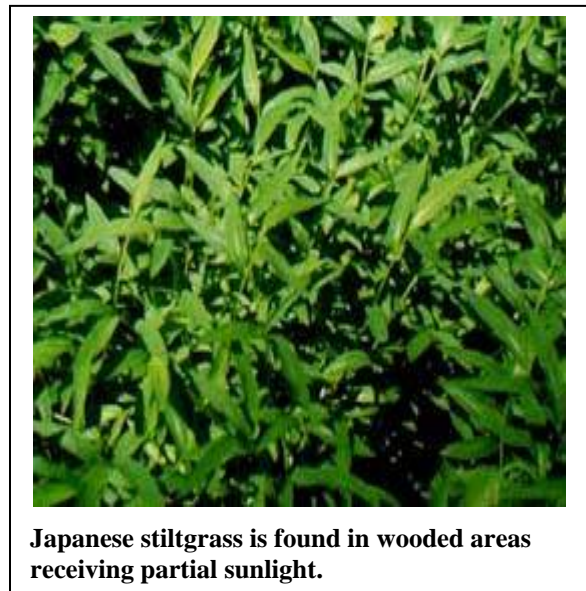
**Figure 4. Examples of common invasive plants found in the Warm Springs Run Watershed.**

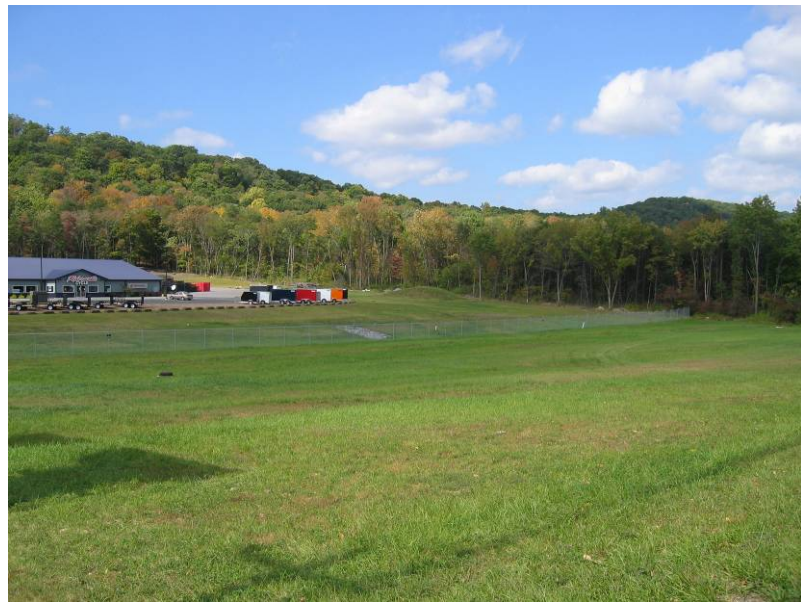
**Figure 5. Inadequate riparian buffer in the headwaters of Warm Springs Run.**

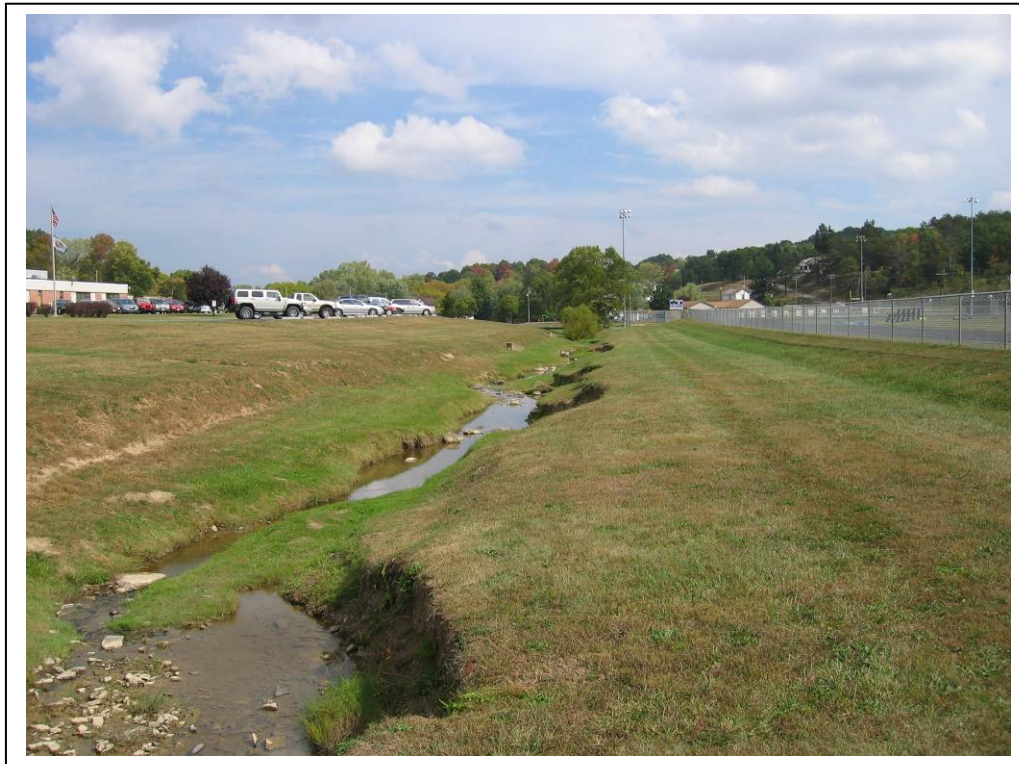
**Figure 7. Inadequate riparian buffer at Widmyer Elementary where the stream divides the school property.**

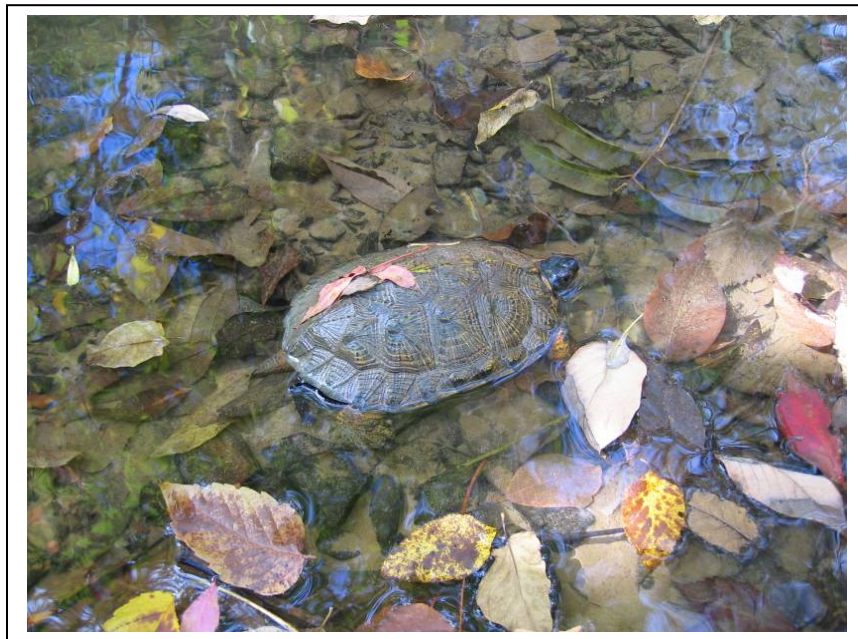
**Figure 9. Despite the degraded quality of the stream, Warm Springs Run is utilized by many species of wildlife, like this wood turtle.**

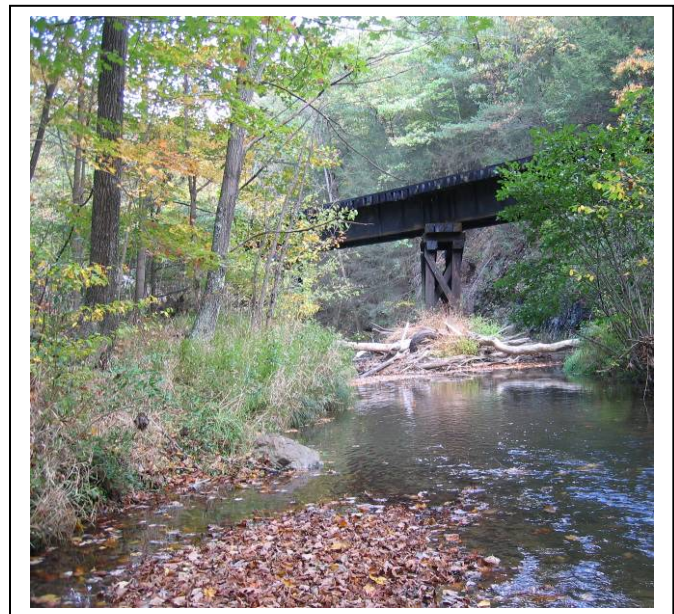
**Figure 11. Debris jam and channel alteration caused by the railroad bridge in Section 7.**

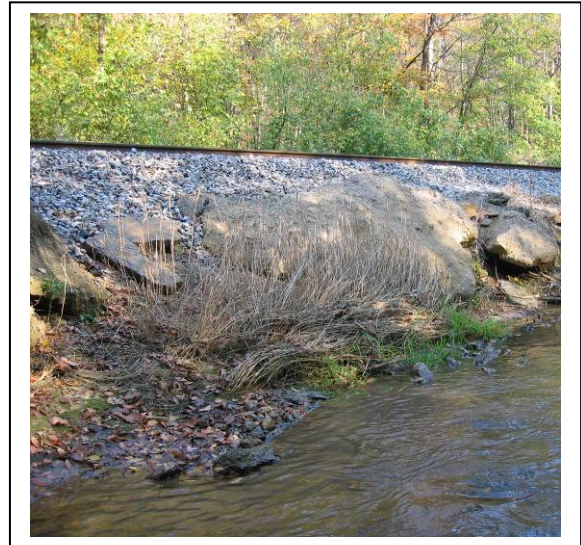
**Figure 12. Herbicide used along the railroad to control riparian vegetation.**
